REPAIRING ASPHALT PAVEMENT

WORK DONE FOR THE CITY OF CHICAGO
UNDER CONTRACT IN 1911

A REPORT PREPARED BY THE
CHICAGO BUREAU OF PUBLIC EFFICIENCY

OCTOBER, 1911

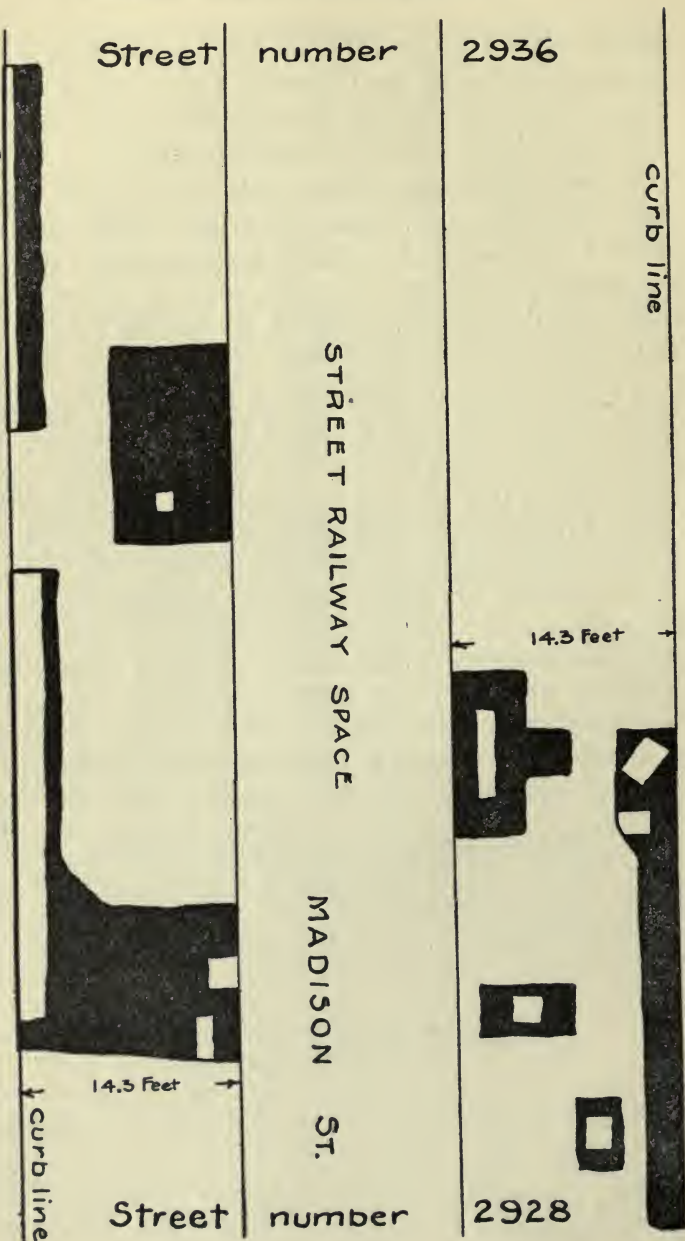
Specific instances were noted by Bureau investigators, at the time of repairing Madison street and Clark street, in which the cutting out of the asphalt pavement extended from 6 inches

Fig. 1. The small white spaces surrounded by black in the above sketch represent the areas which should have been repaired as estimated by the engineers of the Chicago Bureau of Public Efficiency. The black portions represent the excess of pavement actually repaired.

to 2 feet beyond the lines laid down by the inspector of the city.

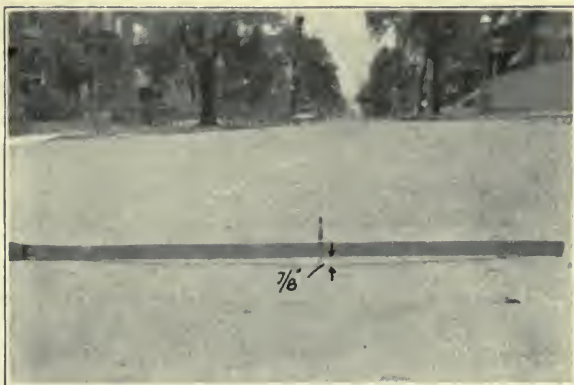
Fig. 2. Prairie Avenue south of Twenty-ninth Street. A 42-inch straight edge laid across the area repaired showed the entire area to be lower than the adjacent pavement. At the center (indicated by arrows) it was $\frac{7}{8}$ of an inch low.

There are some new repairs where practically the entire area is below the surrounding pavement. In one patch about $3\frac{1}{2}$ feet square there is a depression of $\frac{7}{8}$ of an inch. A repair area $10\frac{1}{2}$ feet long and $4\frac{1}{2}$ feet wide contained two depressions of 3 square feet each, in which water was standing to the depth of $\frac{3}{8}$ of an inch. Another repair, 16 feet by 5 feet, had two depressions of 3 square feet each, containing water to a depth of $\frac{1}{4}$ of an inch.

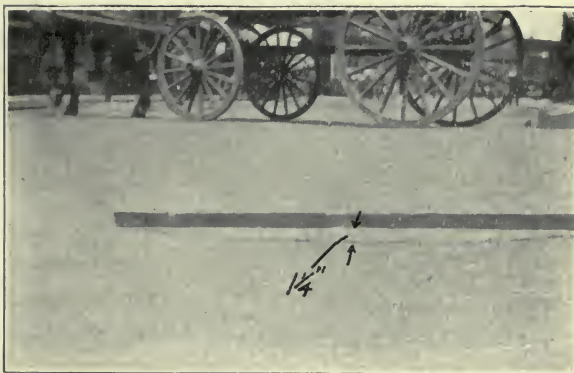
Fig. 3. Clark Street at the intersection with Illinois Street. The binder course on this repair was laid cold and allowed the material to roll which resulted in part of the area being left lower than that adjacent to it. A straight edge laid across the depression showed it to be $1\frac{1}{4}$ inches deep at the center (indicated by arrows).

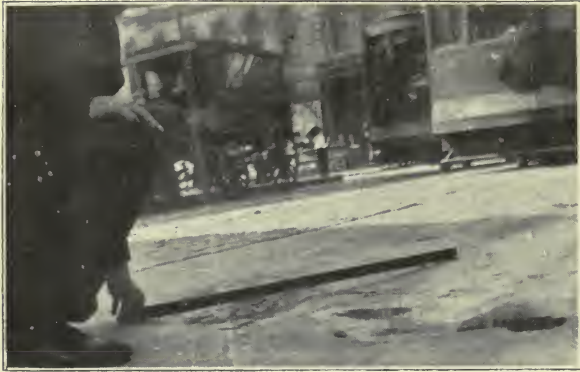
Fig. 4. Clark Street between Michigan and Illinois Streets. This repair was made on June 17, 1911, and the photo taken on July 24—five weeks later. The binder was laid in wet weather and, being defective, did not afford sufficient foundation for the wearing surface, which soon worked forward and left the concrete base exposed. (See area beneath and to the right of the straight edge.)

Lack of inspection is responsible for the wearing surface of a thickness less than $1\frac{1}{2}$ inches, as required by the specifications. Measurements were made where it was only $\frac{1}{2}$ inch. It is also responsible for the rolling of the wearing surface, as can be seen on North Clark street, at which point depressions of $1\frac{1}{2}$ inches are formed, even though this repair has been in use but five weeks.

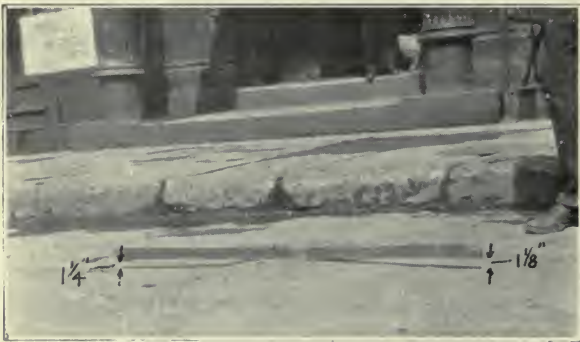
On June 16 a load of binder was unloaded and distributed during a rainstorm, the foreman and inspector standing under an umbrella while the work was being done. When the binder was tamped, water came to the top through the material.

Fig. 5. Clark Street between Michigan and Kinzie Streets. The above figure shows another result of binder being laid in wet weather. In this case the surface has worked up to the center of the repaired area, causing a depression on either side. A straight edge laid horizontally across the center showed the depressions to be $1\frac{1}{4}$ and $1\frac{1}{8}$ inches in depth (the depth is indicated by arrows).
